Deer Impact and Activity Report

Date	07/05/2020
Woodland Name:	Sandon Bury Farm, Compartment 2a, Philpotts Wood
Recorder:	R Smith
Species present:	Fallow, Muntjac
Species doing most damage:	Fallow, Muntjac
Weather Conditions:	Sunny, dry, 16 degrees

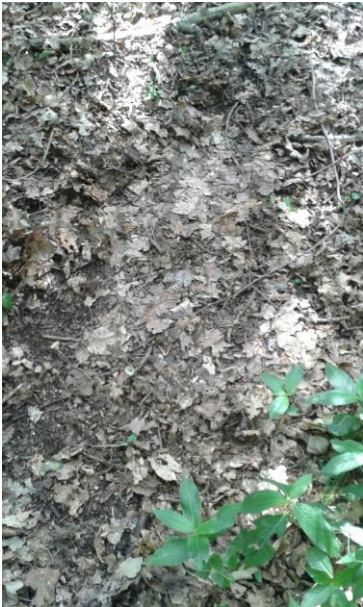
Area where deer lay up has virtually no ground cover

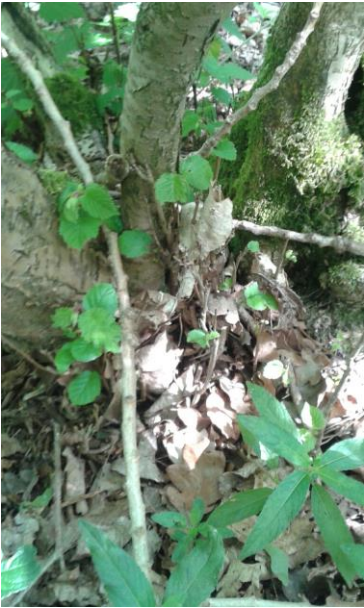
Hazel browse throughout the wood

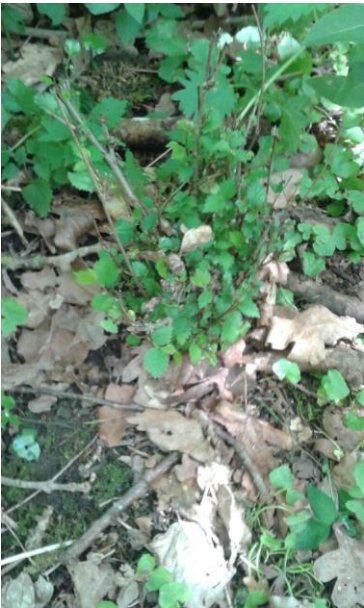
Browse on old stool

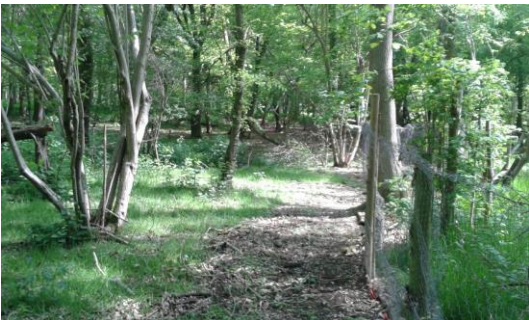
Hazel on the right in the pen has regen, on the left shows no regen and anything within reach has been browsed

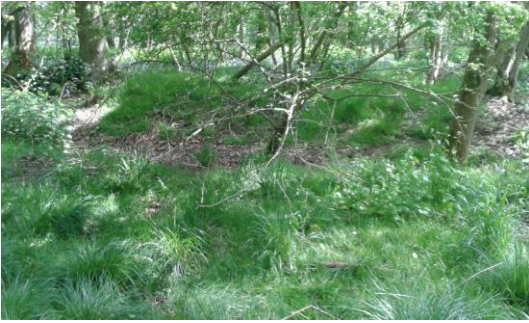
Browse on hawthorn

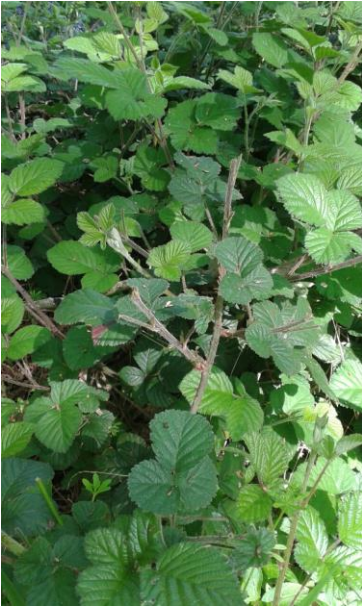
Browse on bramble
